**VADNAIS LAKE AREA WATER MANAGEMENT ORGANIZATION**  
**Sustainable Lake Management Plan**  
**Birch Lake, Ramsey County, MN**

## **SUSTAINABLE LAKE MANAGEMENT PLAN – BIRCH LAKE**

### **MARCH 2020**

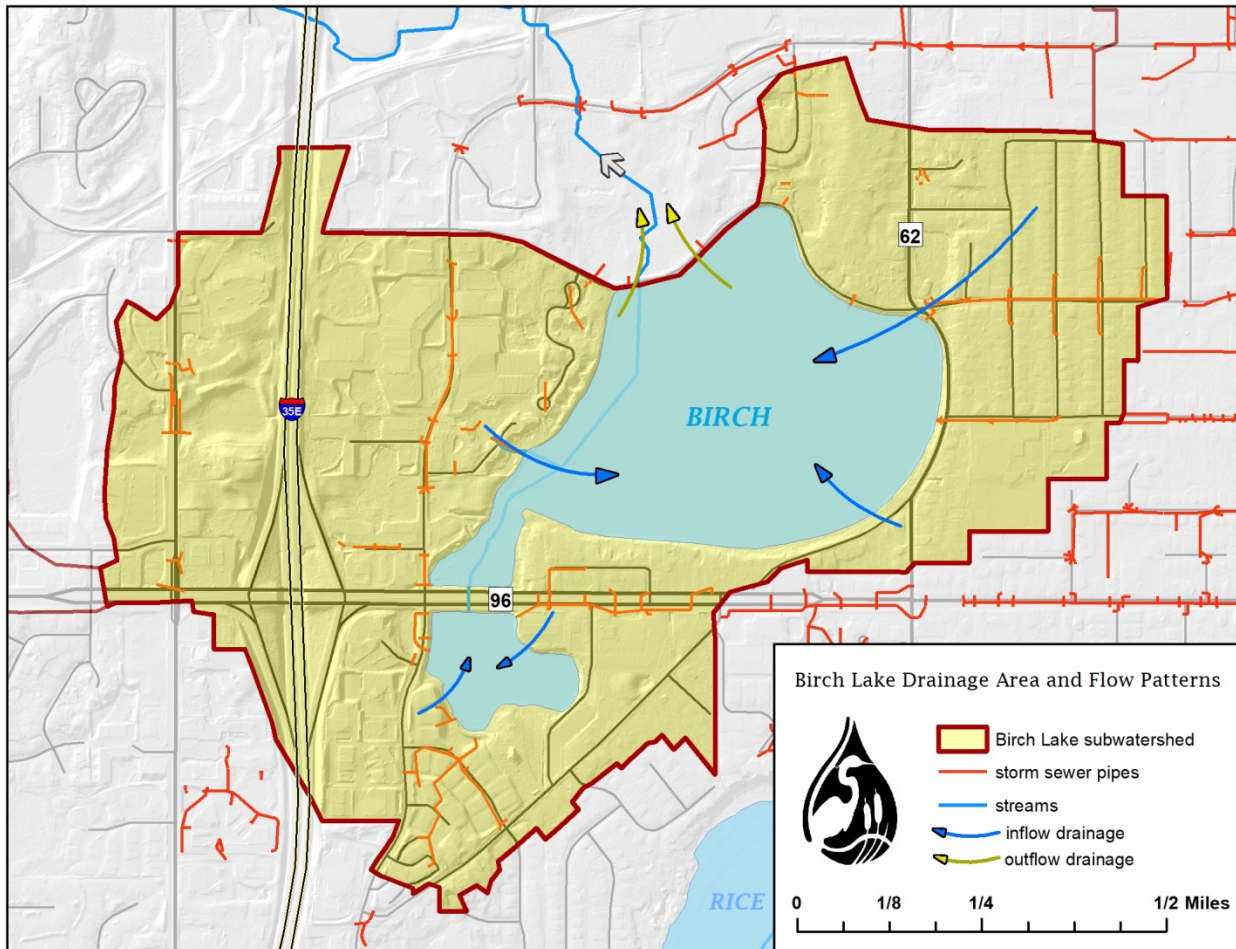
Figure 10: Birch Lake Drainage Area and Flow Patterns

The drainage area (shaded area in Figure 2) into Birch Lake is approximately 575 acres and is about 5 times larger than the surface area of Birch Lake, which is 125 acres. This is a relatively small drainage area to Birch Lake. Lakes with a small drainage area (less than 10:1 ratio) tend to have better water quality.

In 2007 and 2008, VLAWMO collected water samples from 3 areas around the lake where stormwater drains enter the lake to track the levels of nutrients and sediment. Results are shown in Table 1.

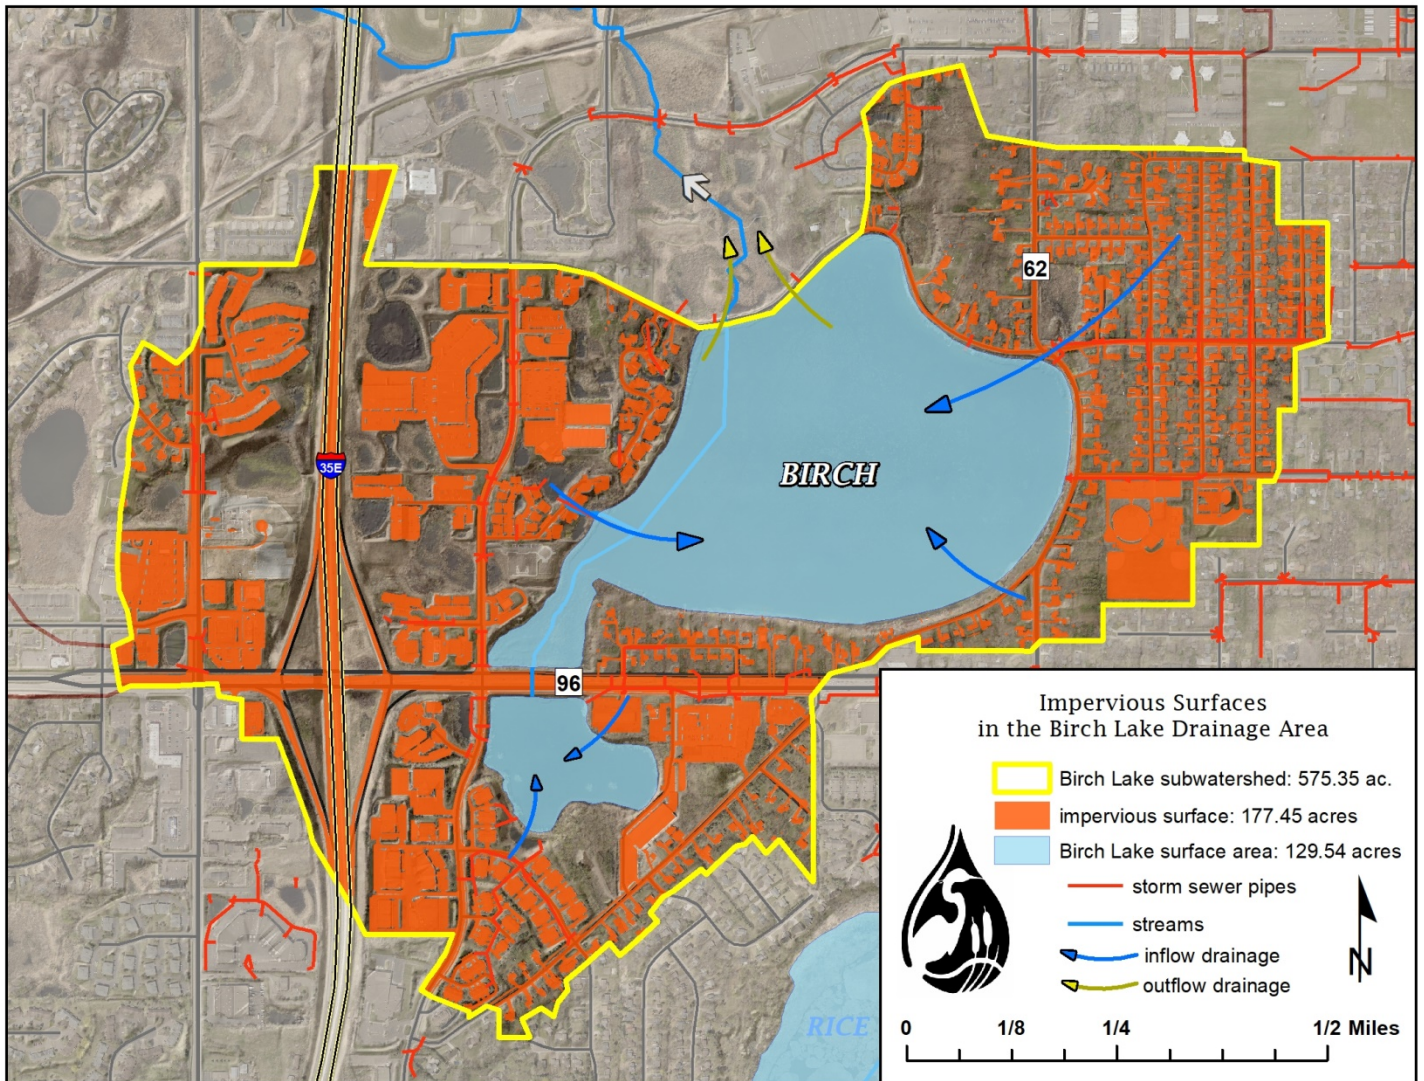
Figure 11: Impervious Surfaces in the Birch Lake Drainage

Figure 11 shows that a large amount of land cover in the Birch Lake Subwatershed is developed, and consists primarily of impervious surface (30.8% of total land cover, including water surface area and undeveloped surface area; not including Birch Lake's surface water area, impervious surface is 39.8% of the total land cover.). The majority of precipitation that falls on those surfaces moves rapidly into downstream lakes, wetlands, and streams.

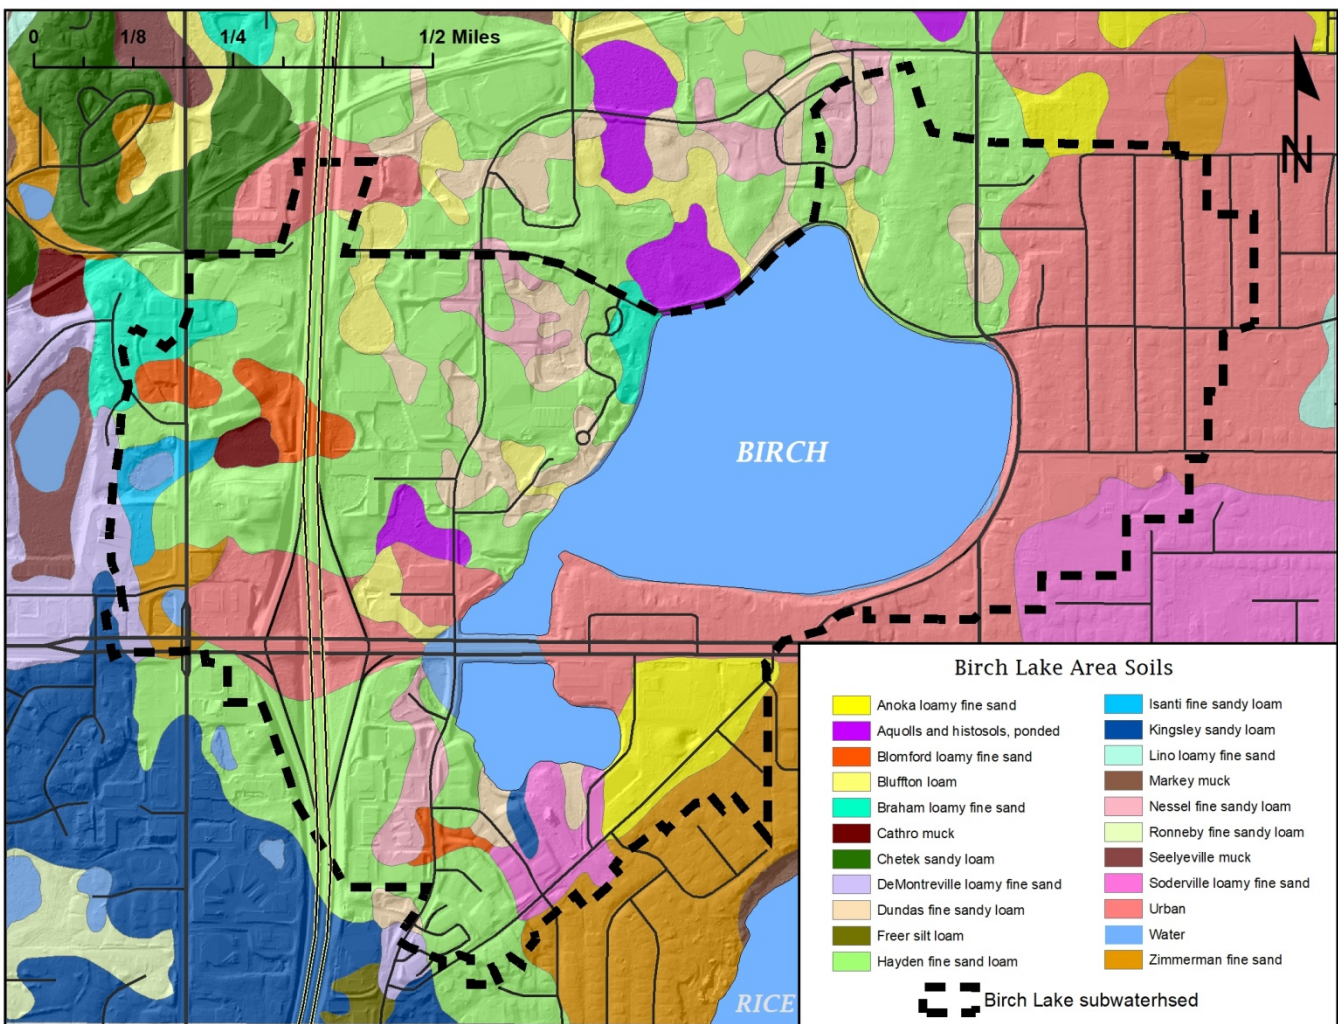
Figure 12: Birch Lake Area Soils

Soils in the Birch Lake Subwatershed are dominated by Hayden fine sandy loam and Urban Land-Zimmerman Complex. Both soils are good for building and residential development. These soils tend to be well drained, allowing water to infiltrate. With development, much of the soil has been compacted, moved, and paved over. Retrofits such as raingardens are especially effective in these soil types and have been added over time.

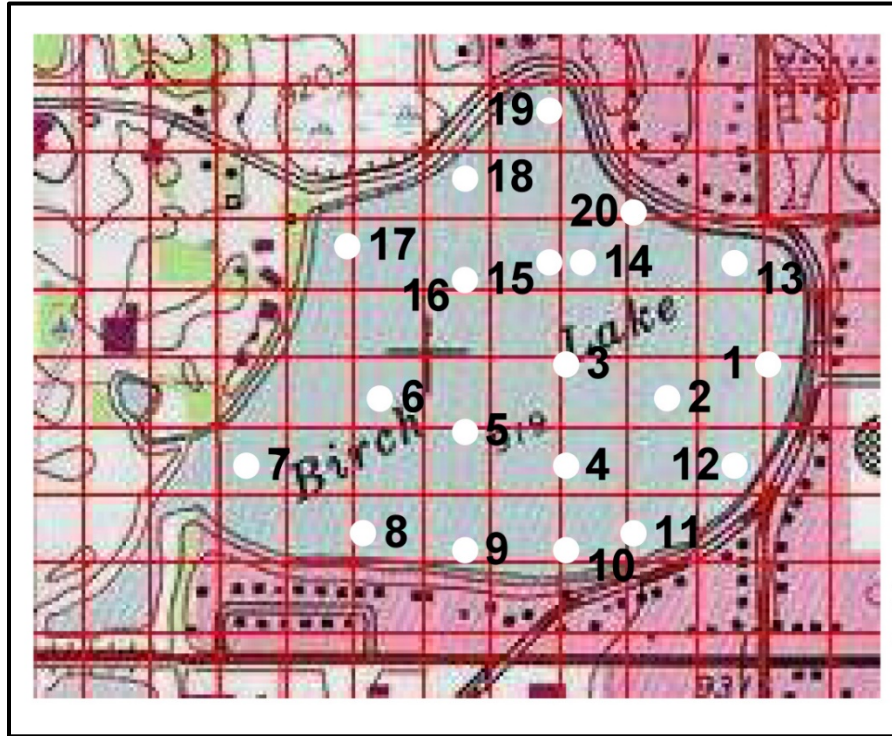
*Figure 13: Birch Lake Sediment Sampling*

Soils in Birch Lake sediments have also been analyzed. A sediment study in the lake was conducted in 2008 to inform the Aquatic Invasive Species Action Plan that was completed in 2015. The lake sediment study was conducted with uniform sampling of the lake area. A total of 20 samples were collected and analyzed.

A total of 15 parameters were analyzed for each sediment sample (see full list in the report included on the VLAWMO website -> Birch Lake). Lake sediments overall are soft and mucky. Typically high organic matter content is associated with the soft mucky sediments sample sites. Lake sediment phosphorus concentrations at all sites were low.

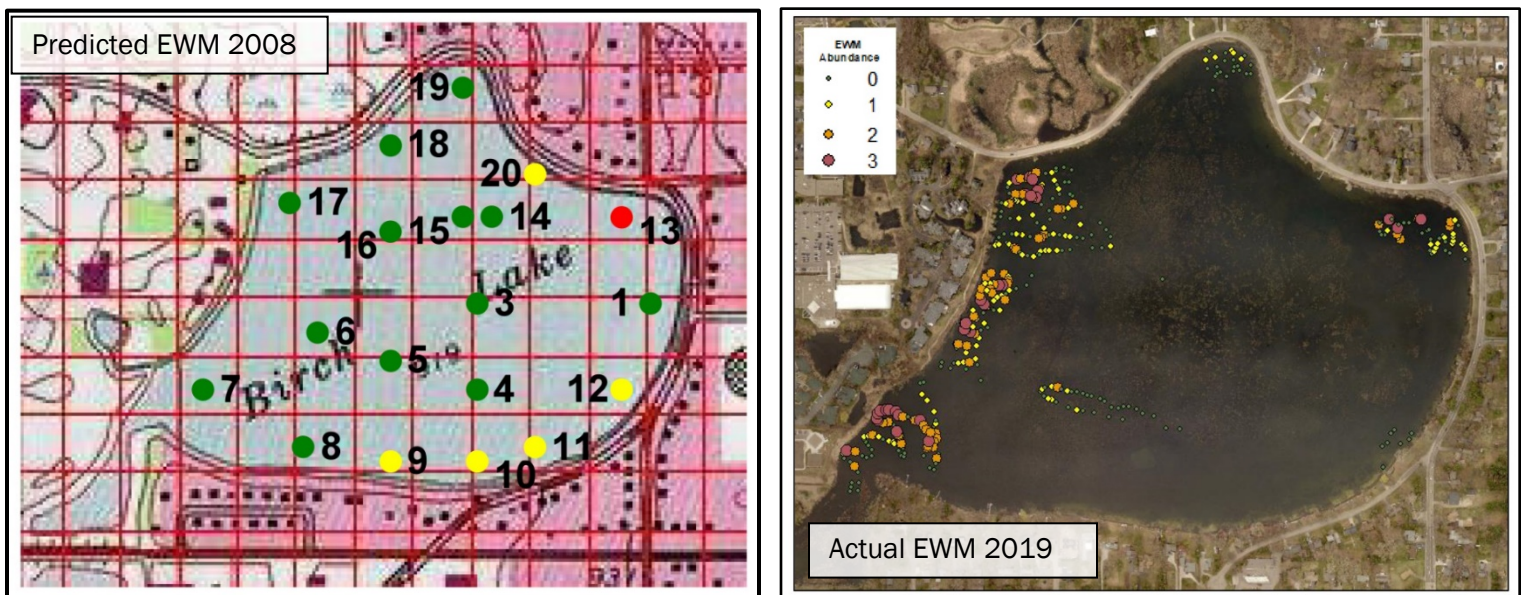
Lake sediment sampling results were also used to predict lake bottom areas with the potential to support nuisance Eurasian watermilfoil (EWM) growth. EWM was first documented in Birch Lake in 2005. Based on the key sediment parameters of  $\text{NH}_4$  and organic matter (McComas, unpublished), the predicted growth characteristics of EWM were investigated and predicted. Sediment nitrogen conditions in Birch Lake are relatively high. However, because organic matter content is very high, nuisance milfoil growth was predicted to be rare. EWM may grow widely through Birch Lake, but it was not expected to produce extensive perennial nuisance matting conditions. Ramsey County Soil and Water Conservation Division conducted an aquatic vegetation survey and EWM delineation in 2019, so we are able to compare predicted versus actual growth of this invasive species. EWM has spread since 2008. Predicted areas for colonization of EWM do not closely match with actual colonization that has occurred over time.

Figure 14: Birch Lake Predicted EWM Growth (2008). Green = low, Yellow = medium, and Red = high predicted coverage by EWM versus Actual Colonization (2019)

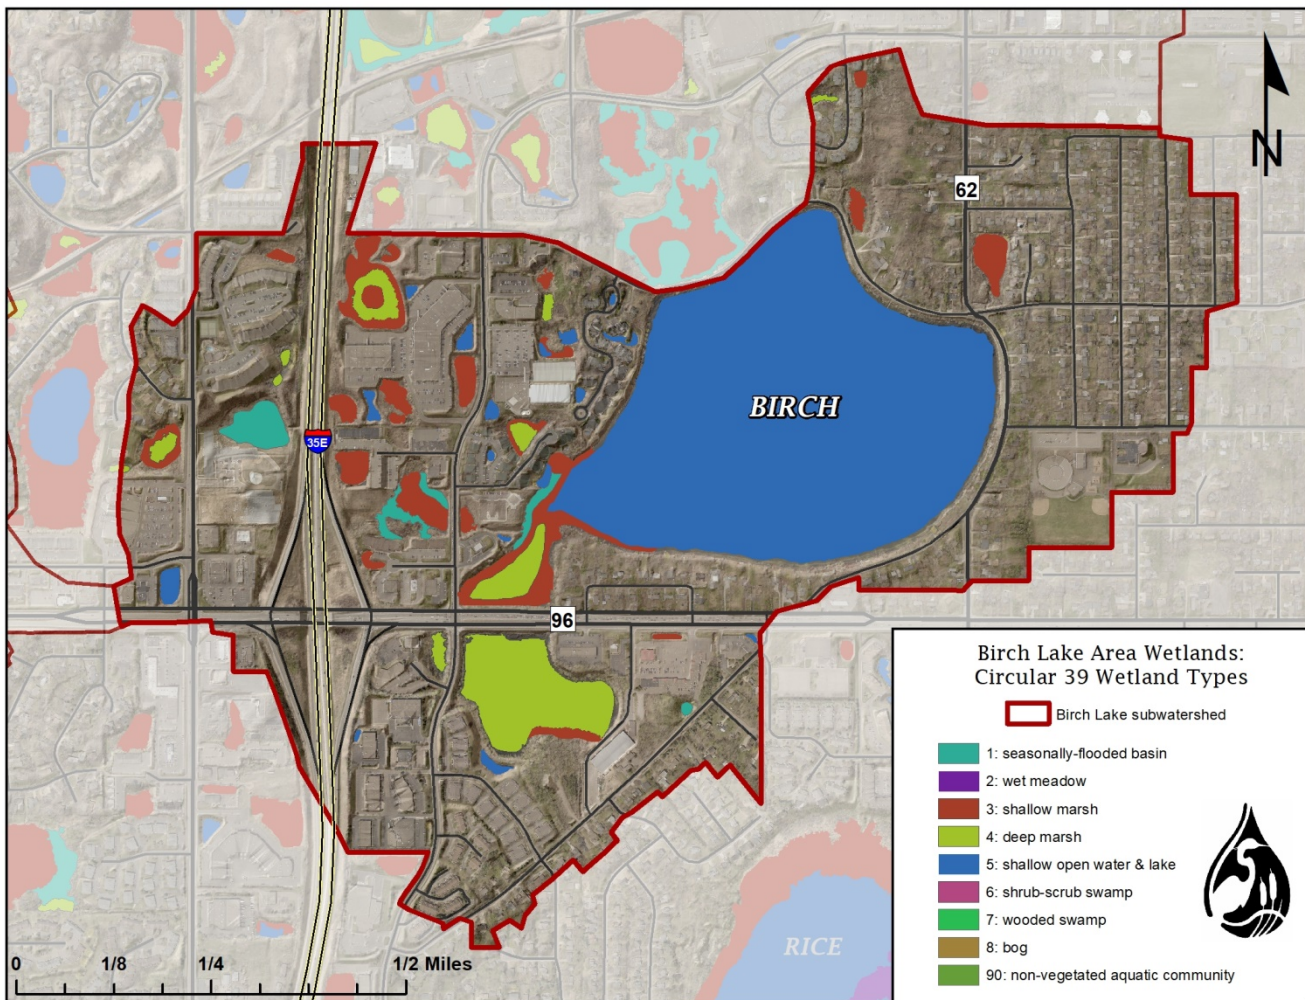
Figure 15: Birch Lake Circular 39 Wetland Types

As Classified by the Circular 39 wetland classification system, the southwest bay of the Birch Lake and the lobe south of Highway 96 (South Birch) have mixed classification of deep and shallow marsh, while the greater area of Birch Lake is classified as shallow open water or lake, as the majority of the lake's perimeter is surrounded by residential development. The southwest corner of the Lake exhibits the most shallow wetland characteristics with predominantly emergent vegetation, and the western shore has the most lightly-developed or altered shoreline habitat.

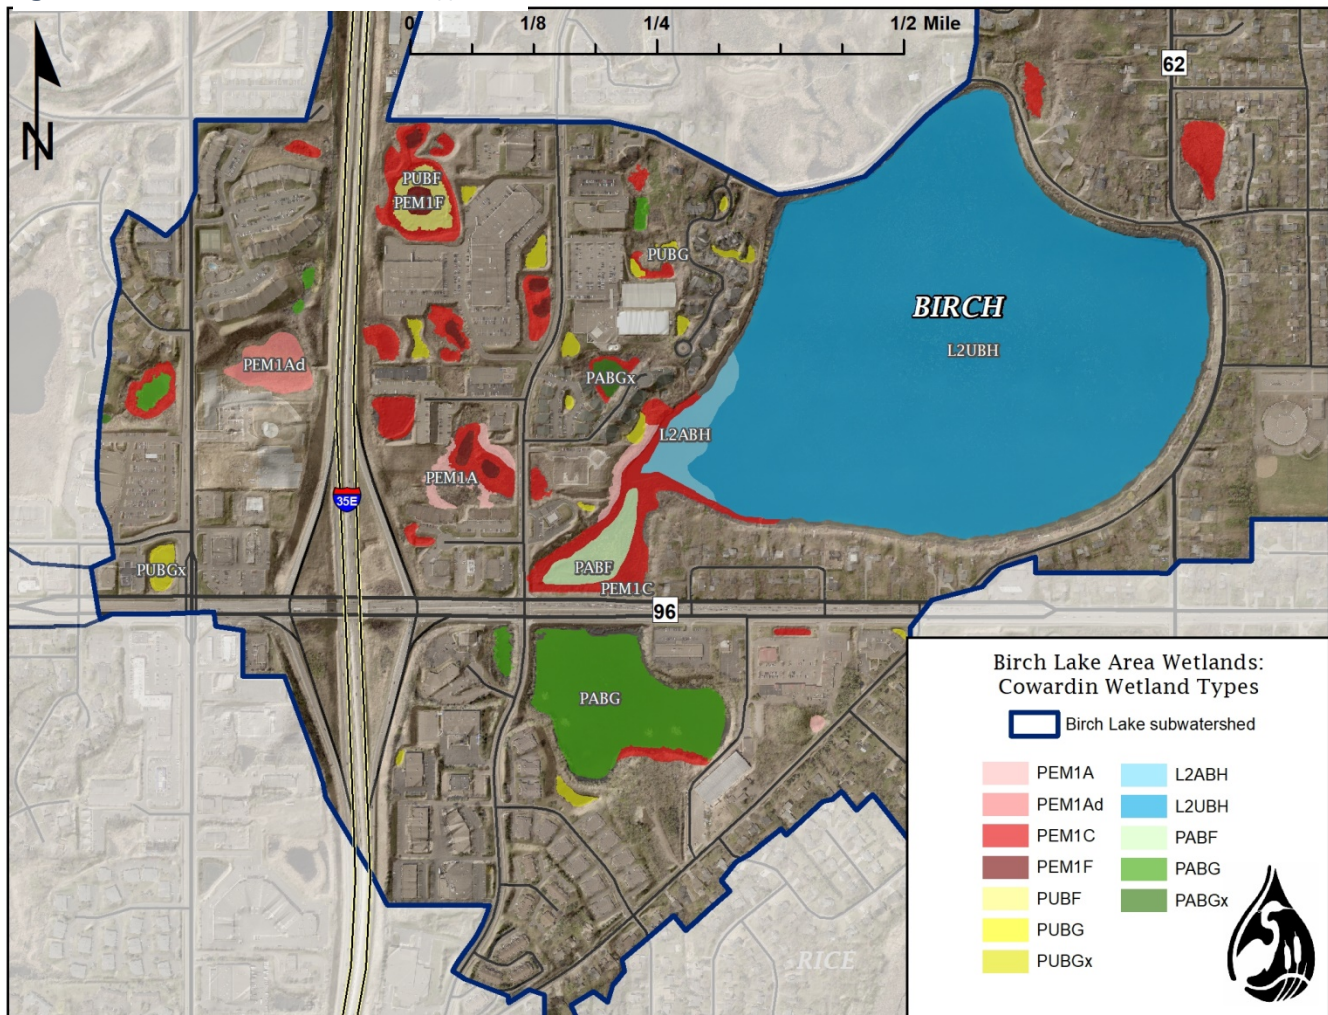
Figure 16: Birch Lake Cowardin Wetland Types

Within the US Fish & Wildlife Service's National Wetland Inventory (Cowardin Classification System), there are three predominant classifications around Birch Lake that are non-Lacustrine (lake): PEM1C, PABF, and PABG, which correspond to Shallow and Deep Marsh wetlands (Figure 16). PEM1C refers to palustrine, emergent, persistent marshes that are seasonally flooded (1C), whereas PABF is identified as a palustrine, aquatic bed, semi-permanently flooded. PEM1C surrounds the southwestern shoreline and PABF encompasses the middle of the southwest bay. PABG is identified as being palustrine, aquatic bed, and intermittently- exposed, and is identified as nearly the entire South Birch basin. These areas within the Birch Lake basin and along the shoreline add up to 19.8 acres.

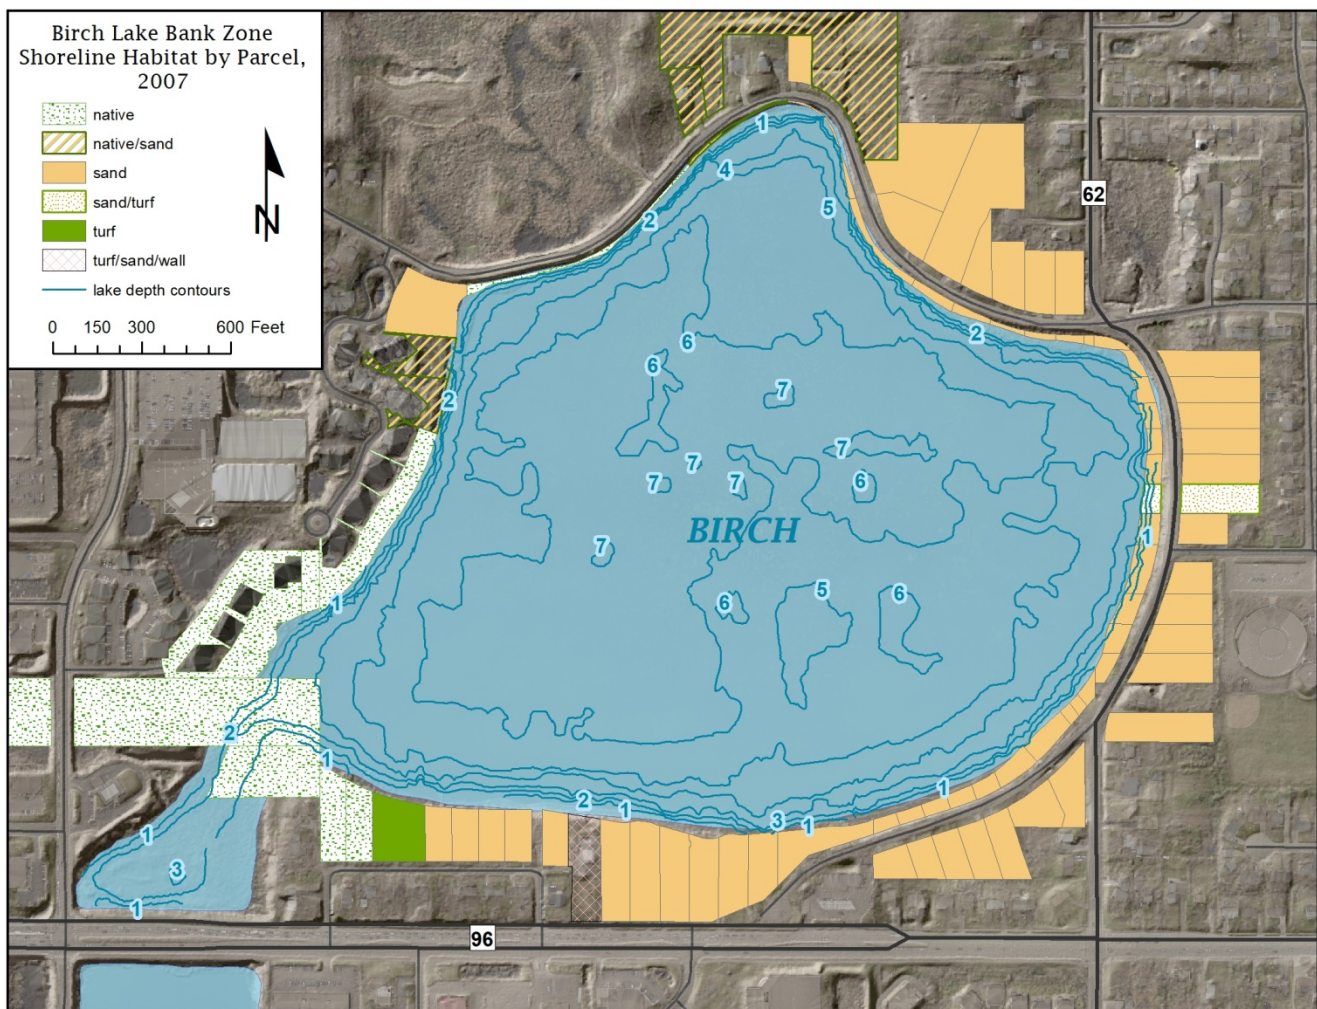
Figure 17: Birch Lake Bank Zone Shoreline Habitat by Parcel

A shoreline survey was conducted by VLAWMO and Ramsey Conservation District (RCD) staff in 2007 (The report was published in 2008). Sixty parcels were evaluated for this effort. Based on our subjective criteria, approximately half of the sites were mostly natural or naturalized, while the other half of parcels were cleared to the shore. There were no signs of major erosion problems. Thirty parcels were deemed to have high potential for shoreline restoration. Nineteen of the properties that are cleared to the shore were determined to have good potential for restoration to a more natural shoreline. By creating a buffer of natural vegetation along the shoreline, there will be more filtering of chemicals from lawns and roads before it reaches the water. Homeowners on Birch Lake should be encouraged to implement these types of landscaping project. Grants and design assistance are available through VLAWMO and the Ramsey Soil & Water Conservation Division to help homeowners with these projects.

A 25-50 foot buffer of natural vegetation that extends both onto land and into water and covers at least 75% of a property's frontage is ideal for the a lake ecosystem. Twenty-five percent of the lake frontage can be mowed and/or used as a beach area. For some people, this requires a change in their idea of what a nice shoreline looks like. Reestablishing natural conditions improves water quality by limiting the amount of

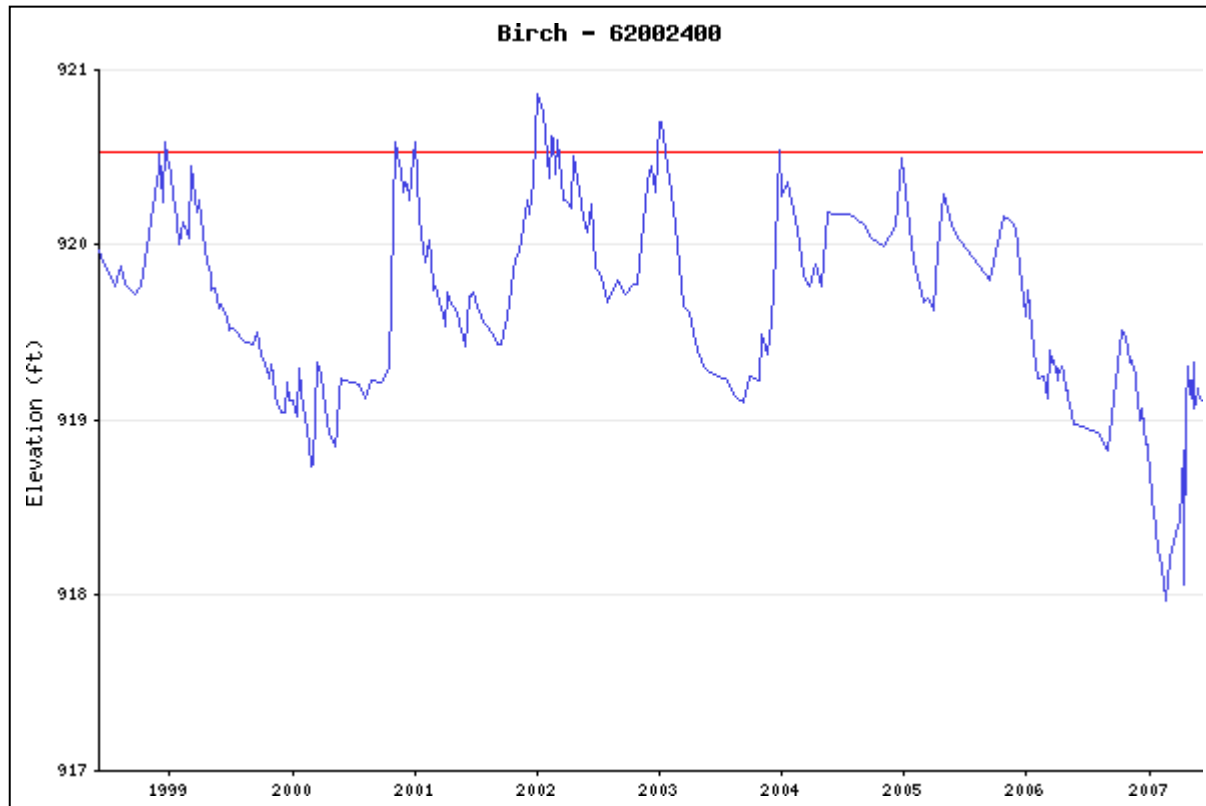
Figure 19: 10-year Hydrograph of Birch Lake

Water levels have fluctuated in Birch Lake since records were taken starting in June 1930 when the lake was dry. The highest recorded level was in 1952 when the lake was 7 feet deep. Water levels from 1998 through 2007 are shown in Figure 19. Birch Lake was approximately 2 feet below its historical average when the original SLMP was developed in 2007. After an especially wet period in 2018-2019, the maximum lake depth exceeded 1952 levels and was 7.4 feet deep. This shows that lakes are dynamic systems that vary over time.

When looking at the lake level data from 1930 to present, there have been other times when the lake level was lower than it was in 2007. The lake was lower in the late 1930s, 1948–1949, 1959, and 1989–1990. In 2007, it was predicted that Birch Lake levels would once again rise to its historical average. That has indeed occurred. As of, 2019, the lake was 7.4 feet deep.

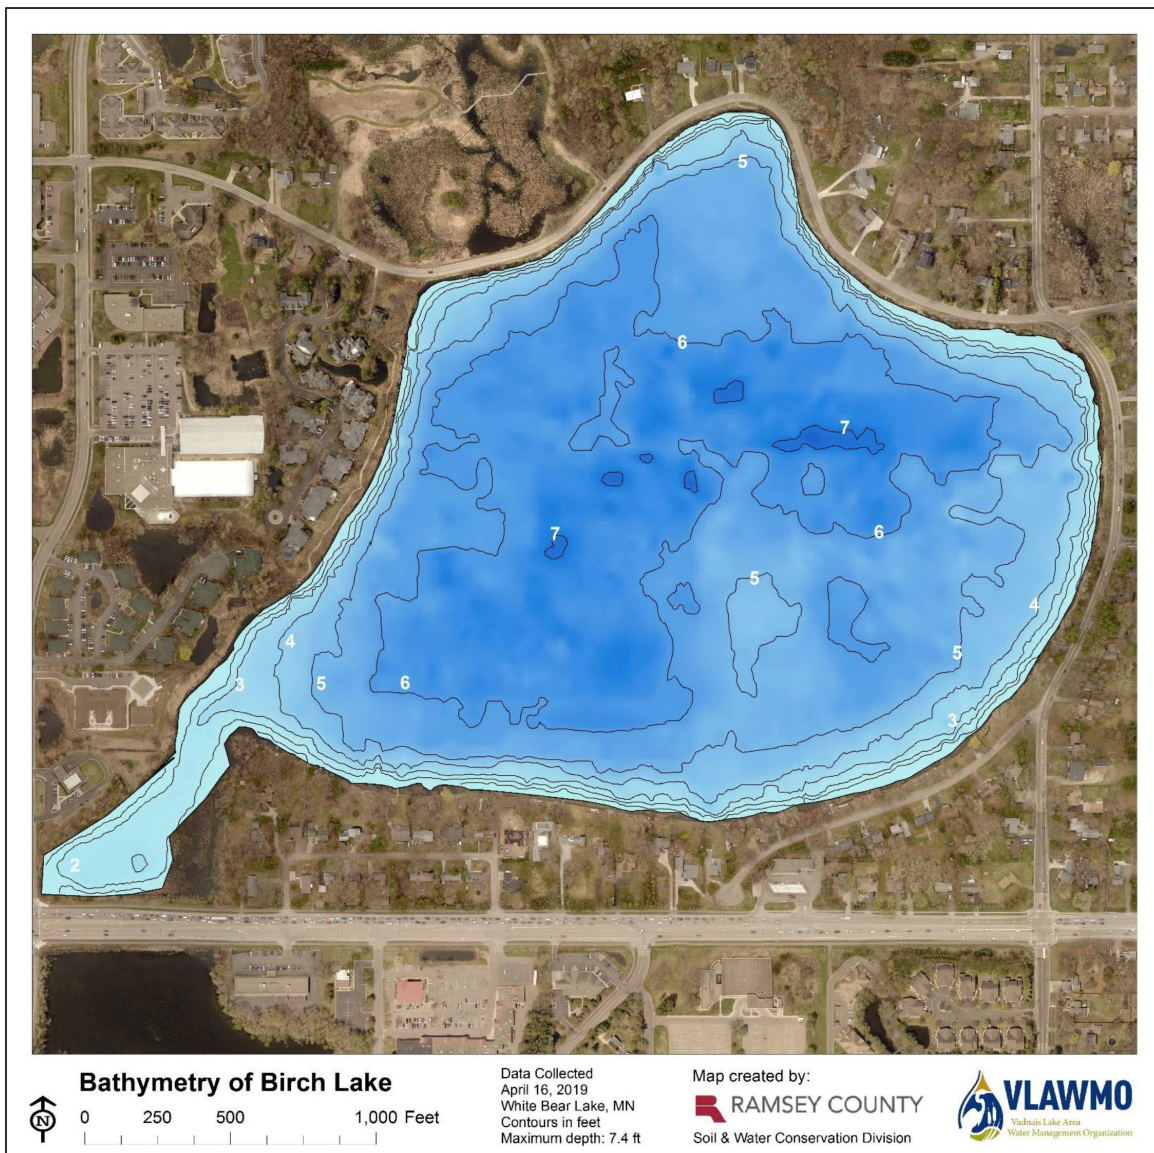
Figure 20: Birch Lake Depth with 1-foot Contours

A bathymetry survey was completed by Ramsey County Soil and Water Conservation Division on April 16, 2019, to develop a map of the bottom of Birch Lake and determine depths. The survey was conducted early (about 1-week post ice out) to capture depths before aquatic vegetation became too thick. Thick vegetation could register as lake bottom and give erroneously shallow readings. Birch Lake has a maximum depth of 7.4 feet. It follows a typical lake bottom shape, with shallower areas along the outer areas and deeper sections towards the middle. Birch Lake has small pockets that are 7-feet deep in the middle of the lake.

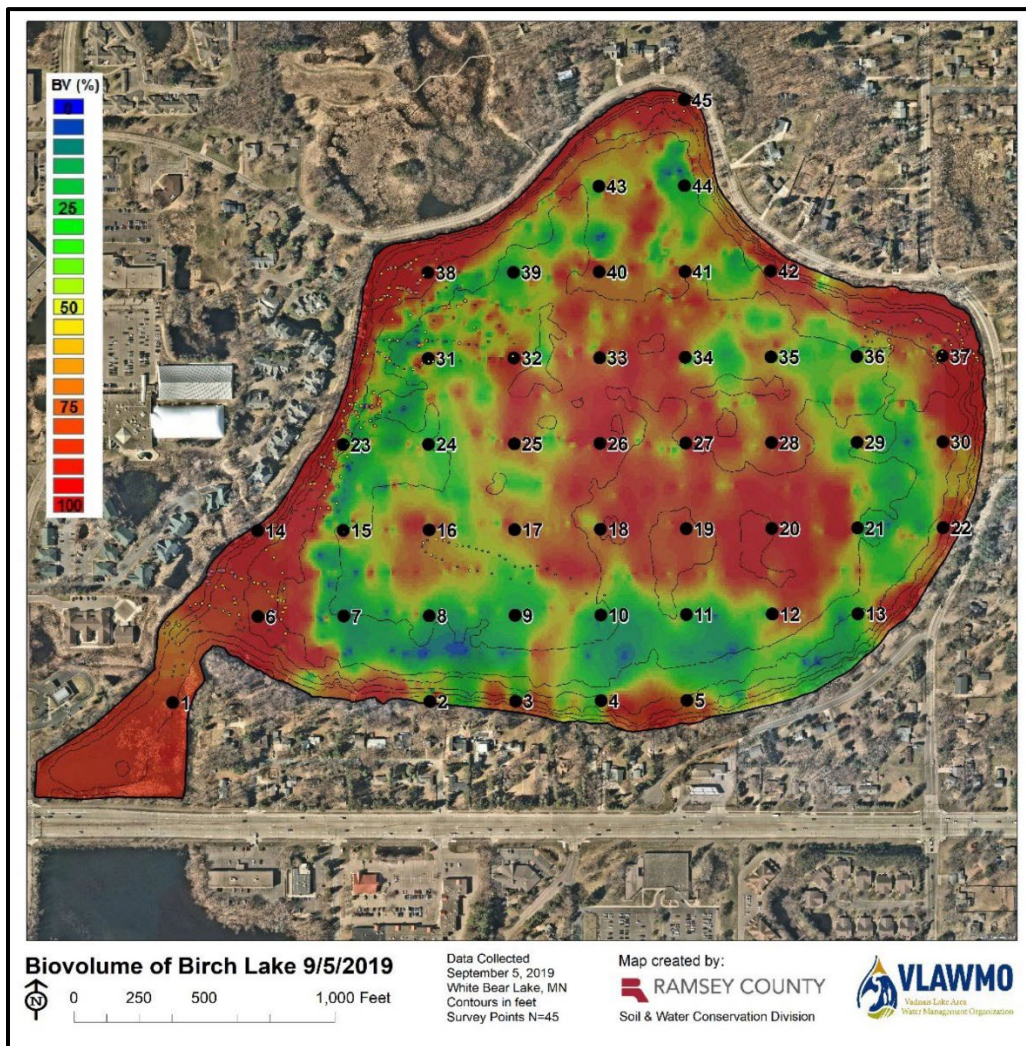
Figure 21: Birch Lake Biovolume

Ramsey Soil and Water Conservation Division conducted a biovolume and aquatic vegetation survey on September 5, 2019. Biovolume measures the density of plant life within the lake. Blue signifies 0% plant life, and red signifies 100% plant life. At depths greater than 4-6 feet, there is commonly no plant life in Minnesota lakes. Plant growth is limited because the sun does not penetrate the water column below those depths enough to allow photosynthesis to occur. Birch Lake has abundant plant life throughout the lake, even in its deepest pockets (Figure 21).

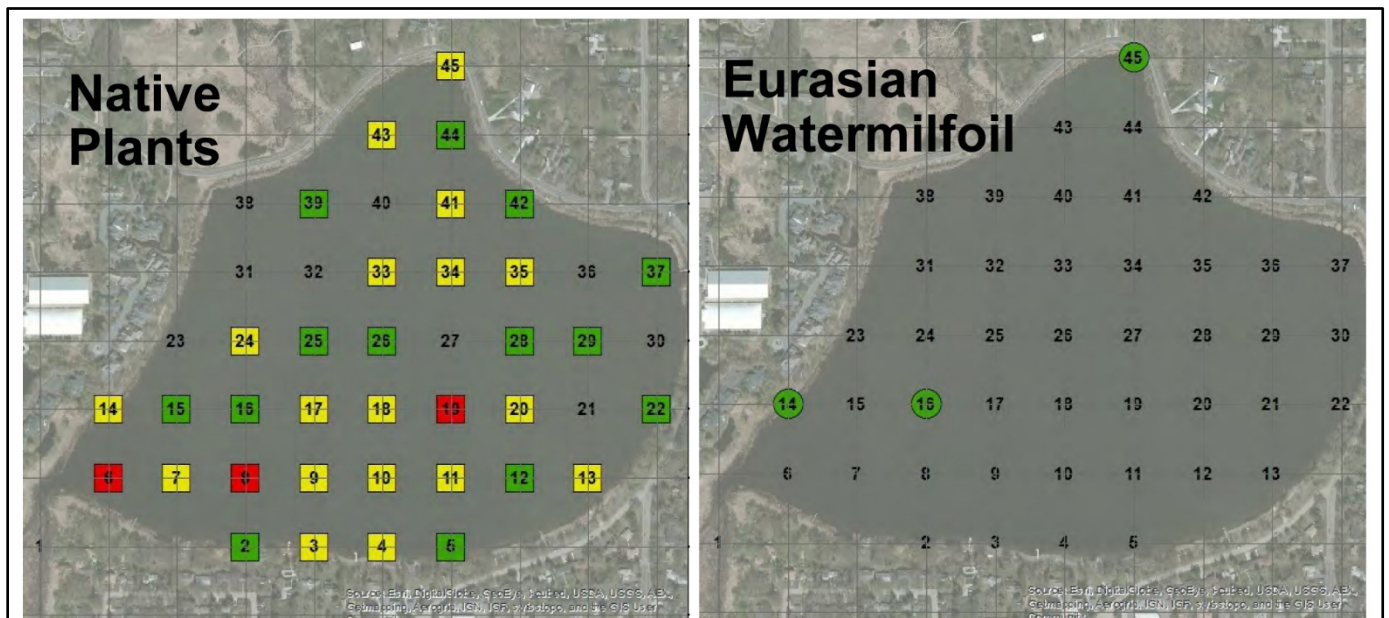
Figure 23 : Birch Lake Native Plant and EWM Locations 2013

[top] Native plant coverage was about 95 acres.

**[bottom] Eurasian watermilfoil, a non-native species, coverage was about 8 acres.**

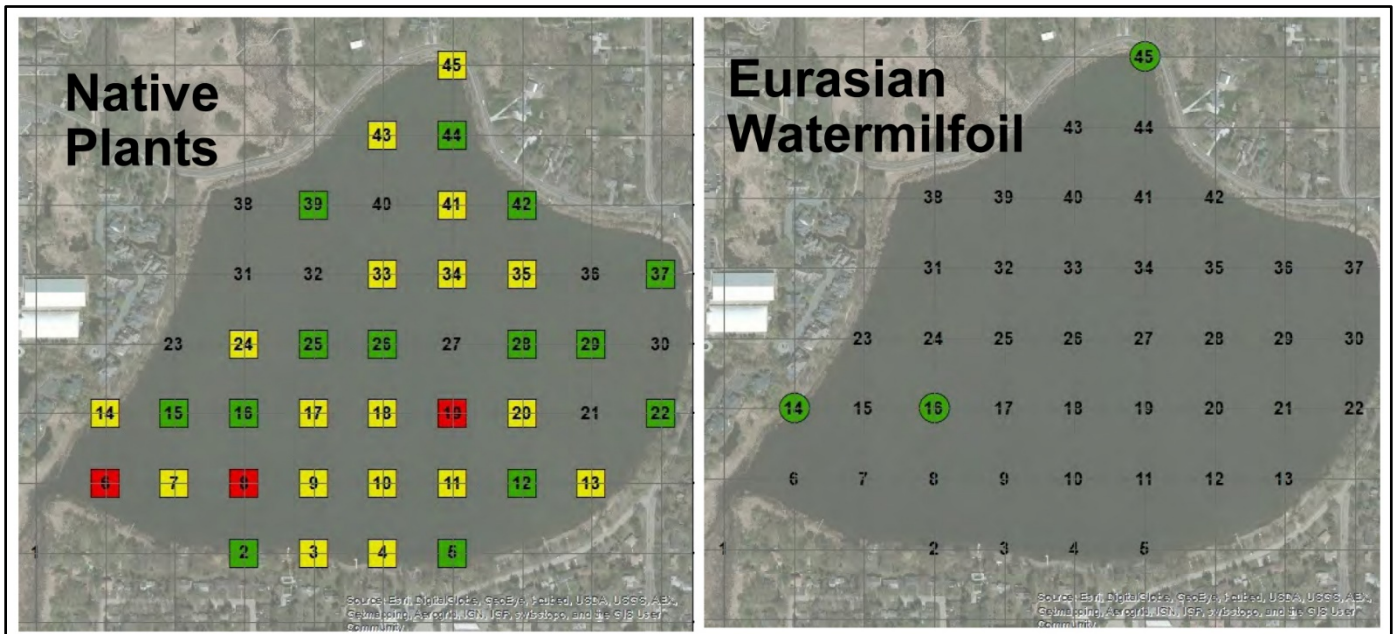
Figure 24: Birch Lake Native Plant and EWM Locations 2015

In **2015**, aquatic plants in Birch Lake were checked at 13 points on September 8, 2015 using the same sites that were sampled in 2013. Results of the 2015 plant check indicated that aquatic plants were similar in abundance compared to the 2013 survey. In 2015, Fern pondweed and Water celery were the dominant plants, which was also the case in 2013. The plant community in Birch Lake in 2015 was similar to conditions in 2013. In 2013, the lake was about 1 foot lower in depth, and plants may have been closer to the surface. Plant distribution and coverage indicated that the lake remained in a healthy condition.

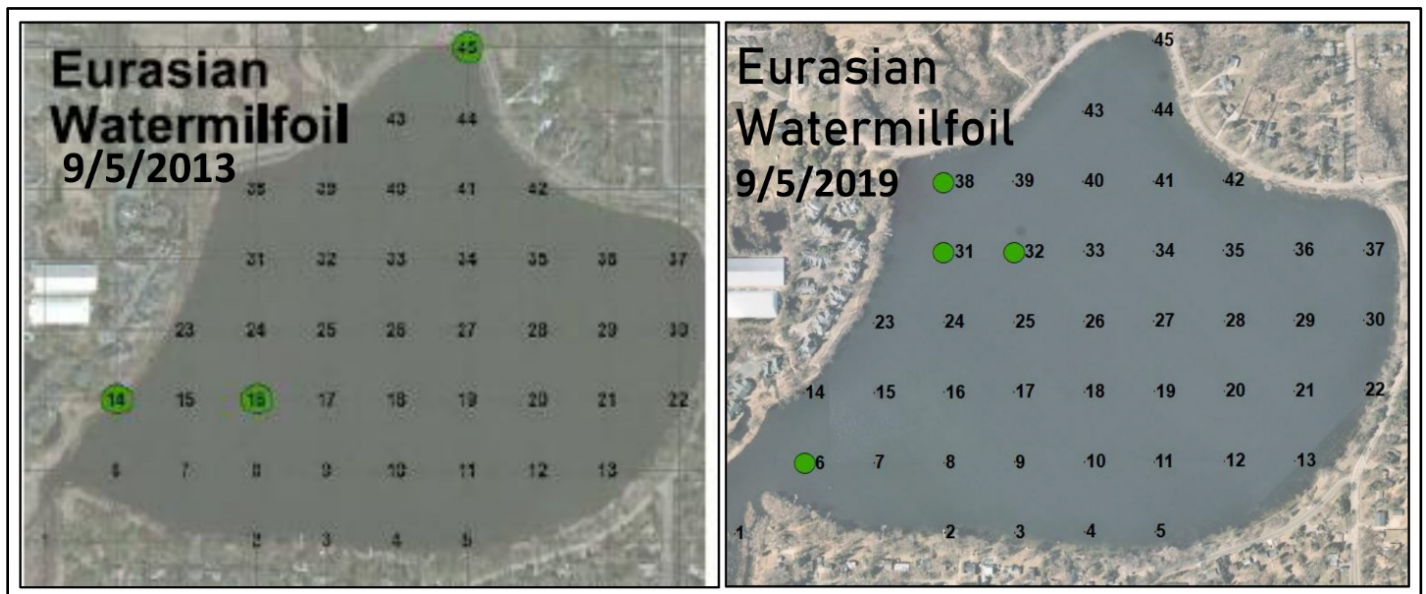
Figure 25: Birch Lake Native Plant and EWM Locations 2015 compared to 2019

The first step of the delineation was the 2019 point intercept survey, in which field staff noted the locations of all points throughout the lake where Eurasian watermilfoil was found, as well as areas between points where it was detected. Next, staff returned to each location where it had been found to conduct a more in-depth vegetation survey in the interest of quantifying the present extent of Eurasian watermilfoil. Figures show the sections of Birch Lake where Eurasian watermilfoil had been detected in the 2013 survey (points 14, 16, and 45) as well as where it had been observed in the 2019 survey (points 6, 31, 32, 38). The northeast was also re-visited due to an EWM sighting between points 36 and 37 on 9/5/2019.

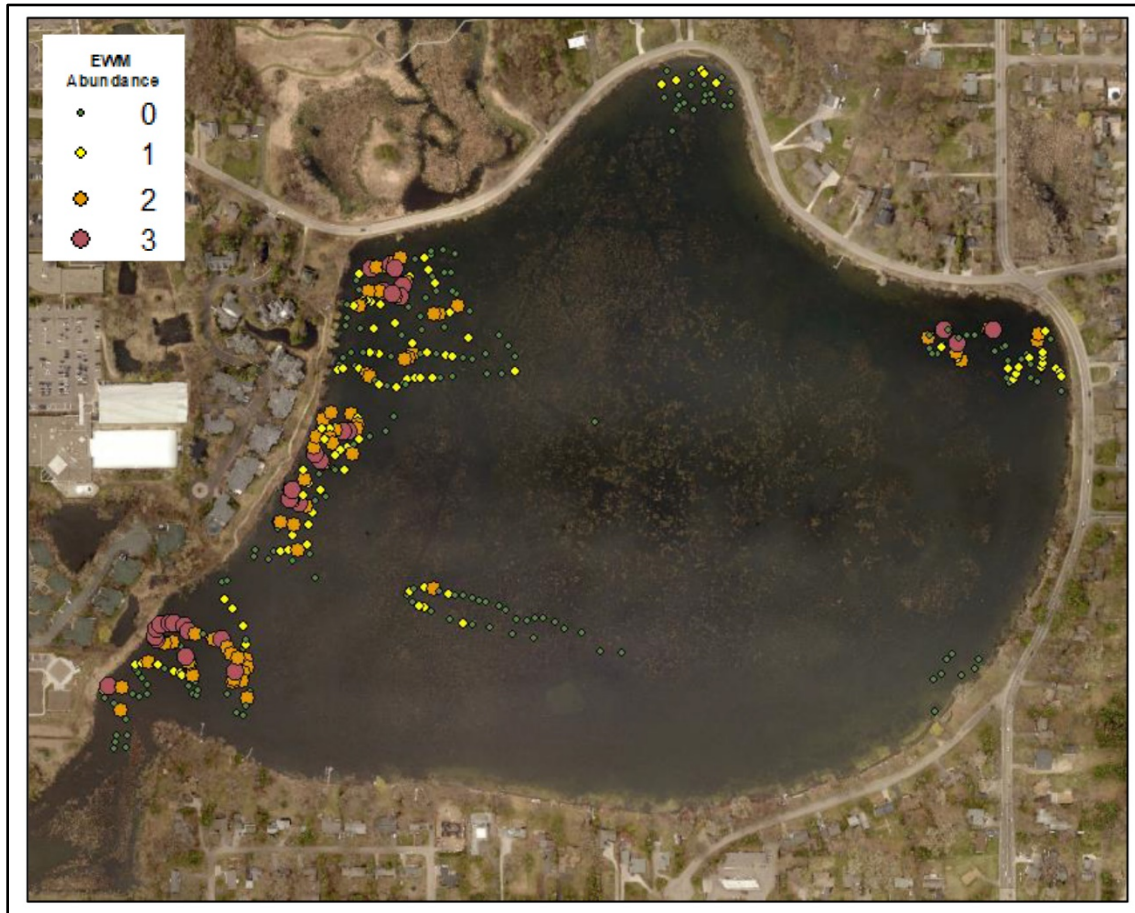
Figure 26: Birch Lake EWM Delineation 2019

Consistent with the MNDNR's manual *Guidance for Delineating Invasive Aquatic Plants for Management*, the target areas were transected in a zig-zag pattern while staff took GPS points to note observation locations and results. Observation points are indicated in the figure below for each target area identified.

Eurasian watermilfoil is widespread in Birch Lake, primarily along the western shoreline and the northeast corner of the lake. Due to the shallow littoral nature of Birch Lake, EWM is not restricted to the shore areas, although it is currently most prevalent in the 3-5 foot depth range. **Total acreage for Eurasian watermilfoil is about 11.4 acres, a rise from the 8 acres found in the 2013 survey.**

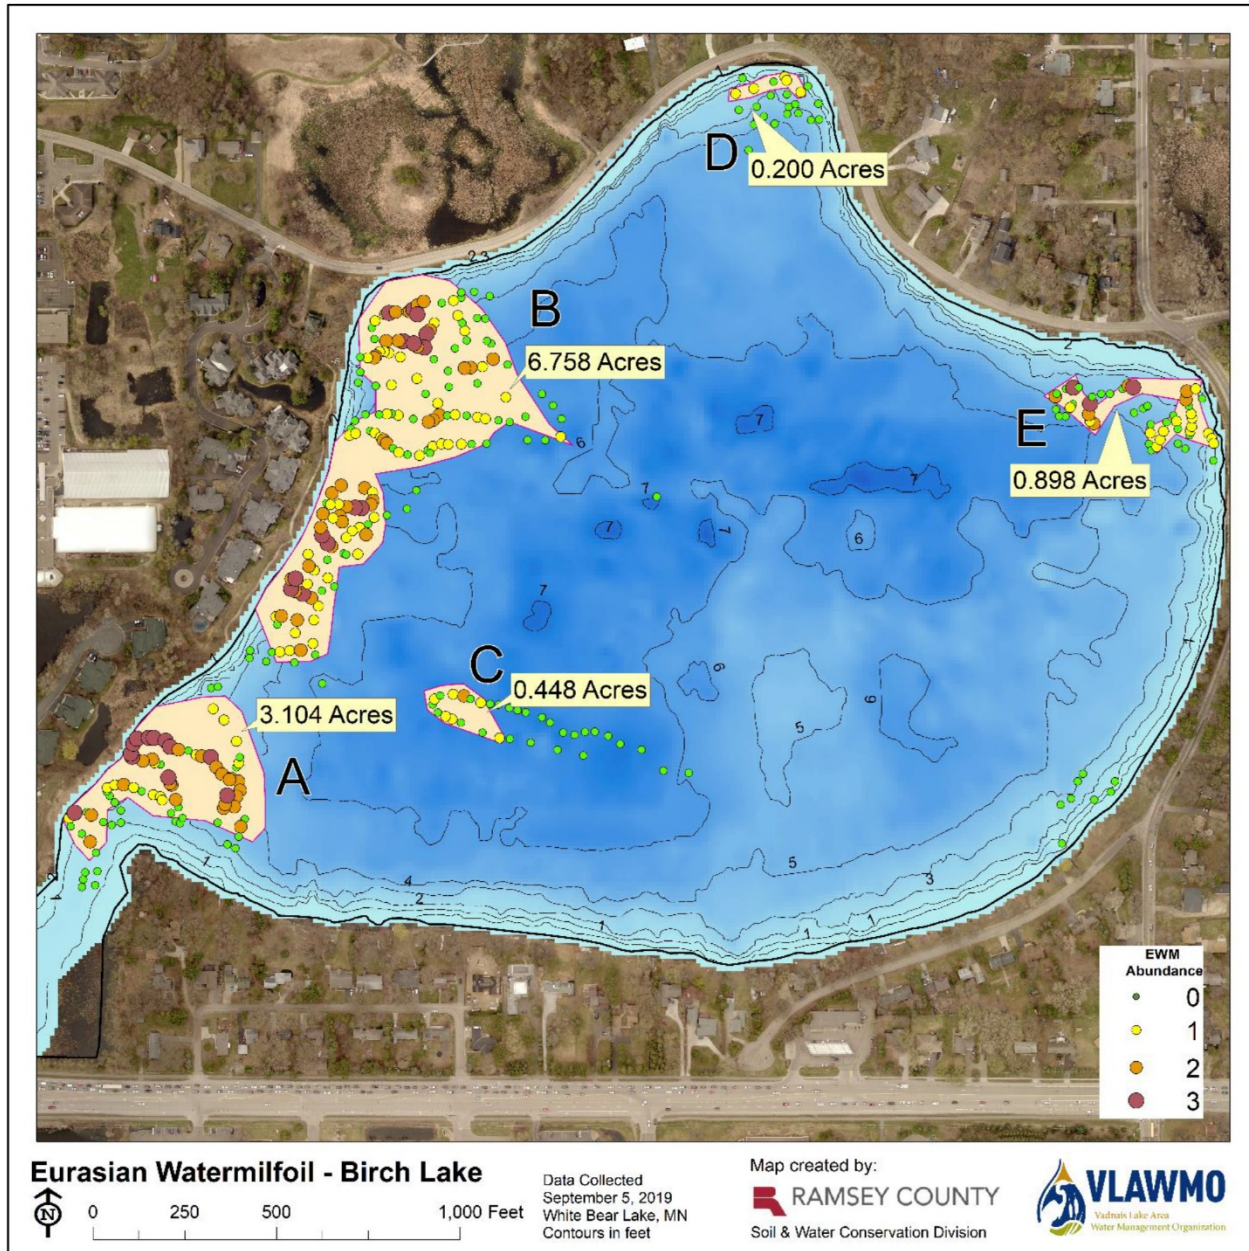
**This is a 42.5% increase in EWM on Birch Lake.**

Figure 27: Birch Lake EWM Extent in 2019. Total coverage is 11.4 acres.

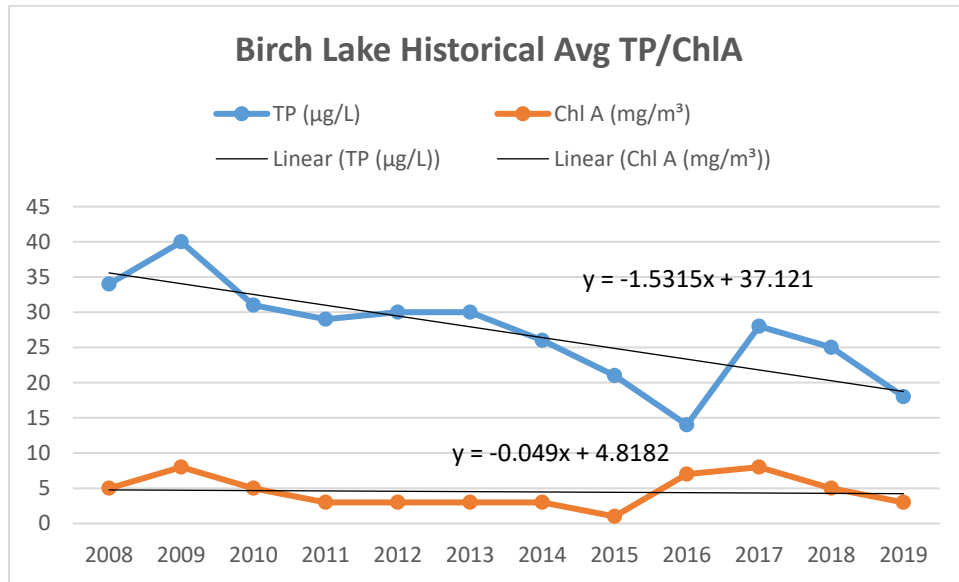
Figure 30: Historical Water Quality Averages in Birch Lake 2010-2019

Figure 30: The graph shows results of TP/Chl-a with a linear trend through time. TP levels are below the State Standard (60 µg/L). Chl-a hovers around the value of 5 mg/m³.
