**VADNAIS LAKE AREA WATER MANAGEMENT ORGANIZATION**  
**Sustainable Lake Management Plan**  
**Birch Lake, Ramsey County, MN**

## **SUSTAINABLE LAKE MANAGEMENT PLAN – BIRCH LAKE**

### **MARCH 2020**

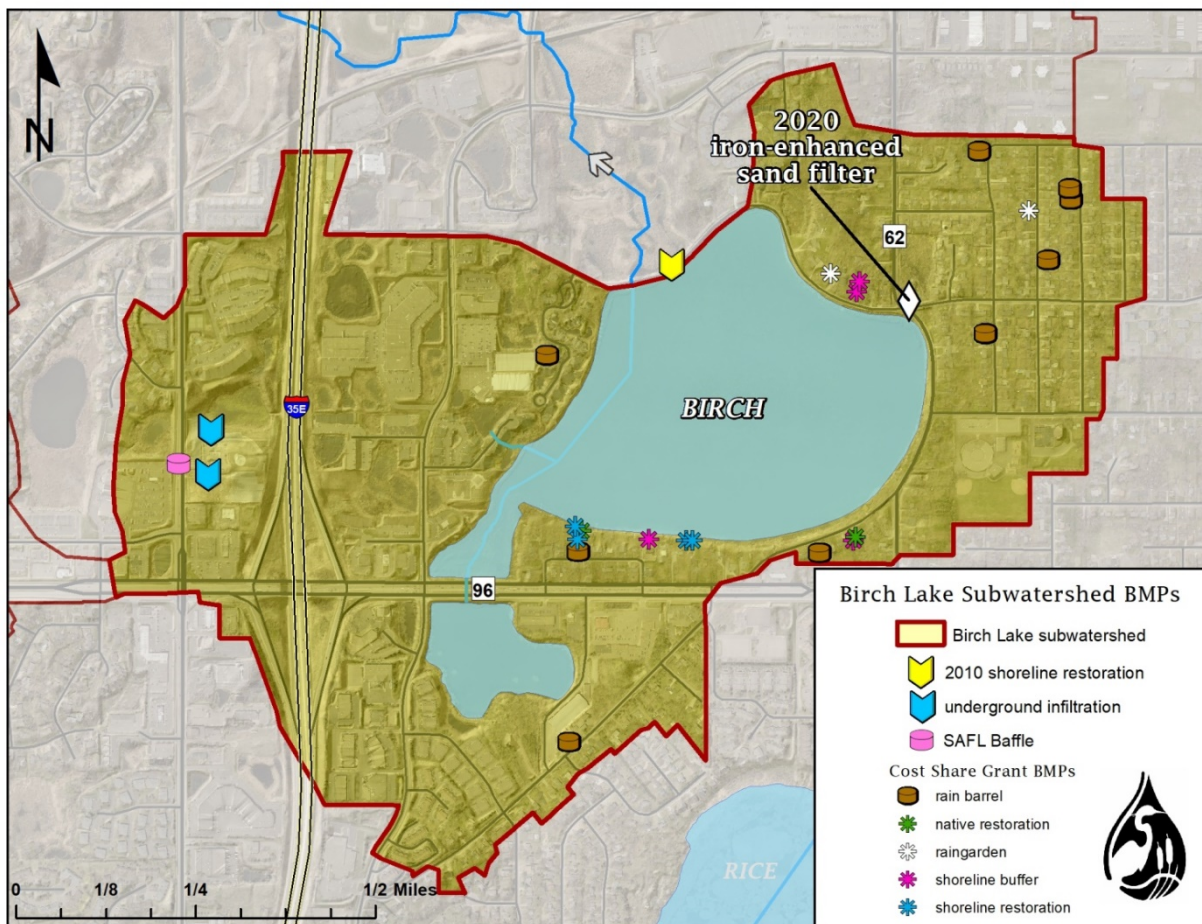
Figure 31: Birch Lake Subwatershed Implemented BMPs

- Large shoreline restoration on the north shore of Birch Lake, completed in 2010.
- Development of the Pillars senior living facility in 2017, Lunds & Byerlys grocery store in 2018, and subsequent reconstruction of Centerville Road prompted installation of underground infiltration cells and SAFL Baffle stormwater treatment.

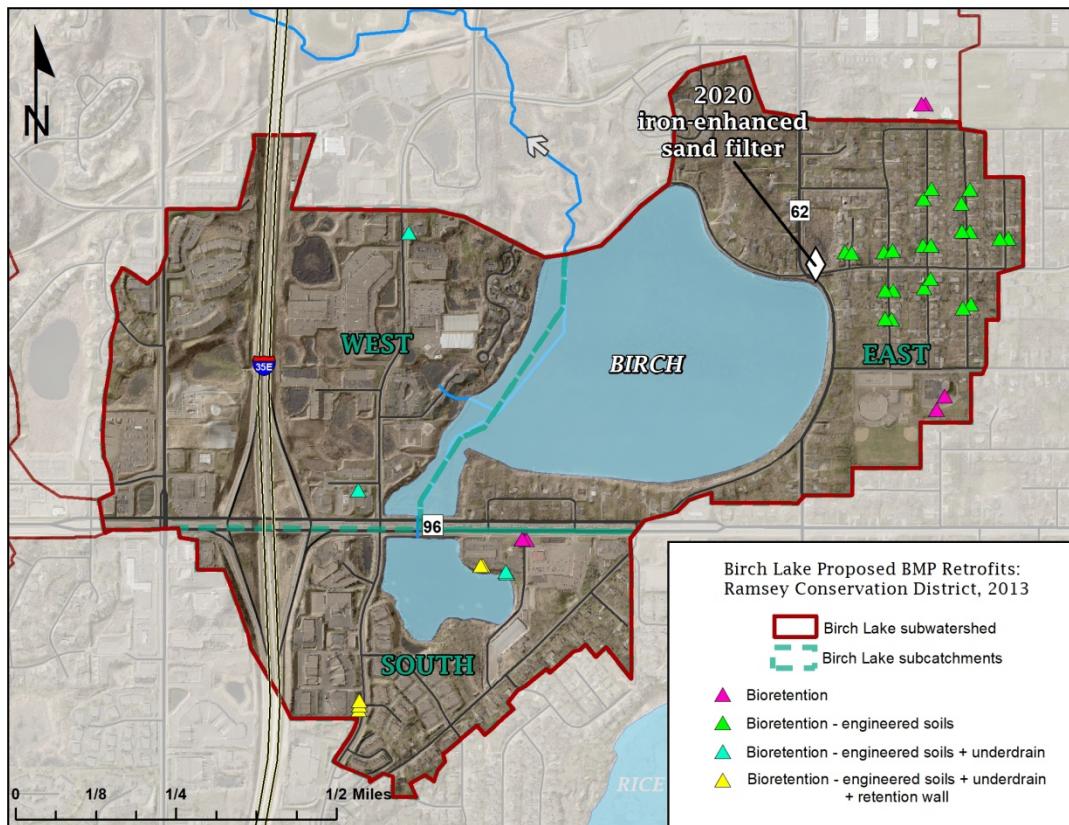
Figure 32: Retrofits identified for the Birch Lake subwatershed. The east side of the subwatershed had the most options. The iron-enhanced sand filter project (for construction in 2020) was selected for implementation for large-scale treatment of the storm sewer system, rather than individual residential raingardens.

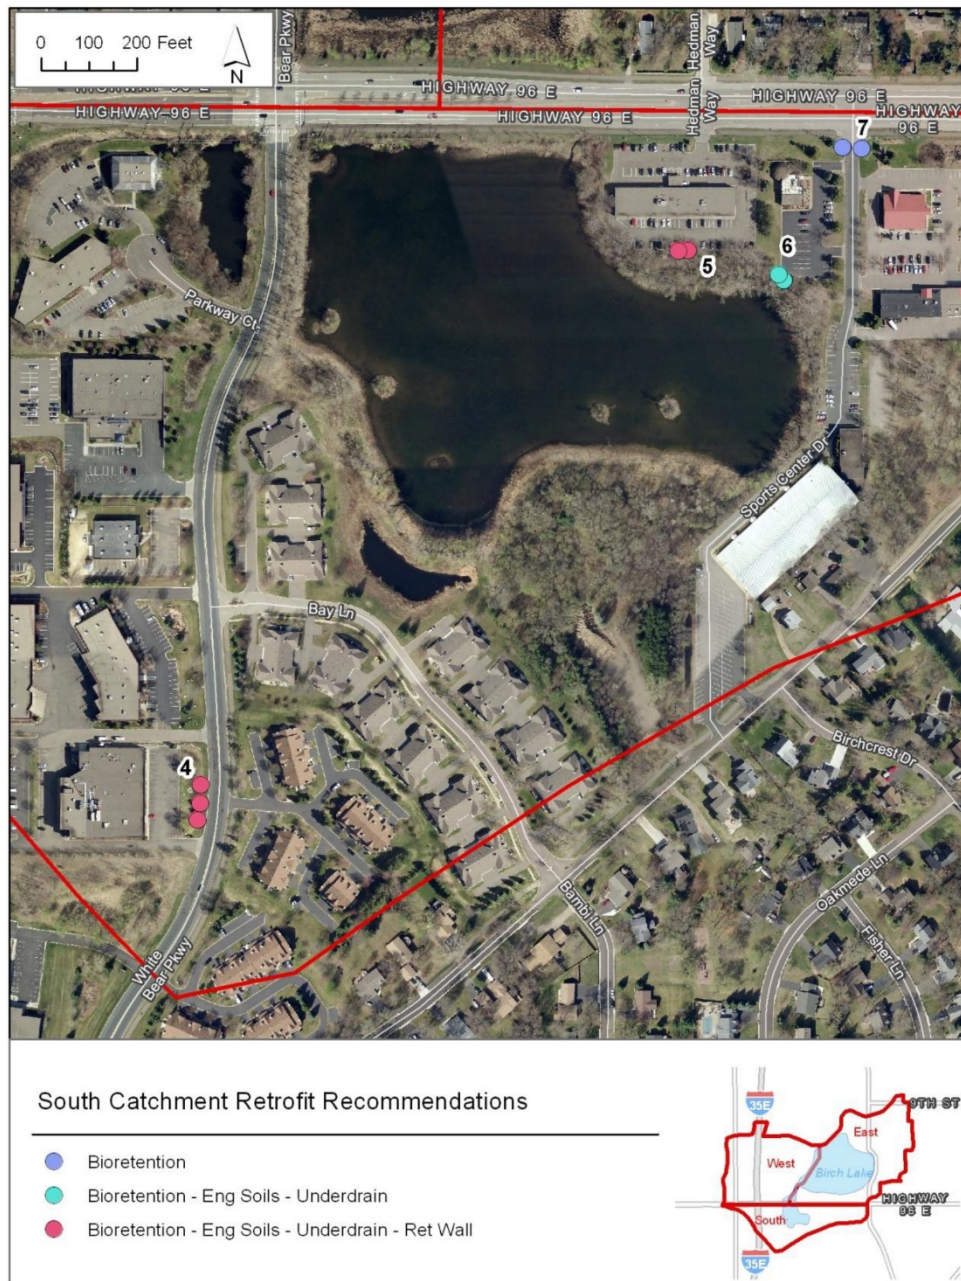
Figure 34: Retrofits identified for the south side of Birch Lake. Nine locations were identified for this side of the lake.

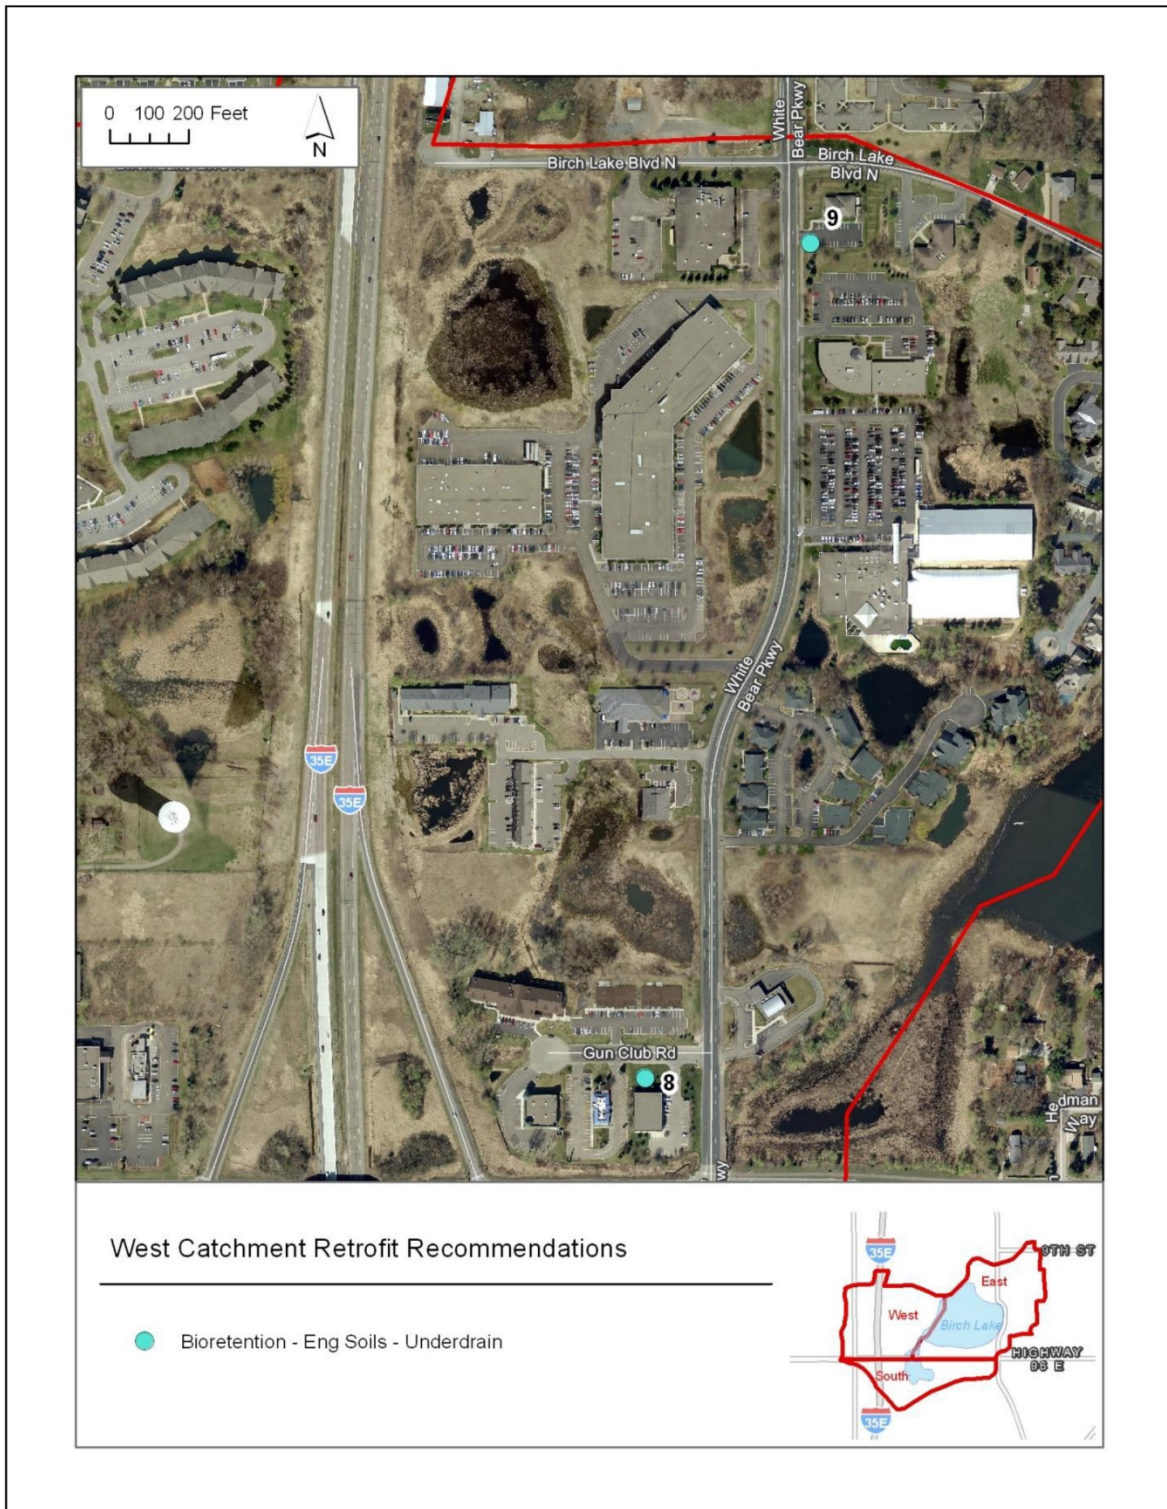
Figure 35: Retrofits identified for the west side of Birch Lake. Only 2 locations were identified for this side of the lake.
